Hahnemann Monument Restoration Project

A Public/Private Partnership

Sandra M. Chase, MD, DHT, Chairman,
American Institute of Homeopathy Hahnemann Monument Preservation Committee
April, 2006

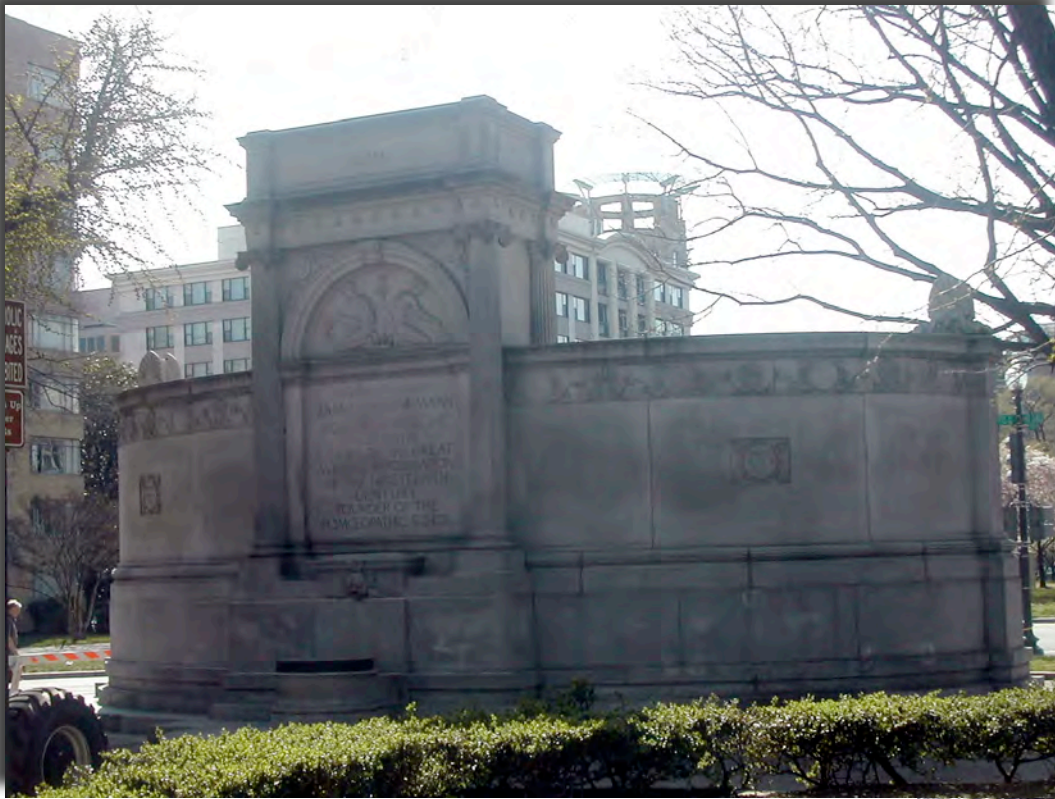
This view of the rear of the Hahnemann Monument was taken on Sunday afternoon, 02 April 2006, as have been the last 10 photographs shown.

The lift brought in to insert the lead T's to prevent water damage in the joints at the top of the monument is still in place on Sunday, 02 April 2006. The area remained cordoned off to public approach, as well.

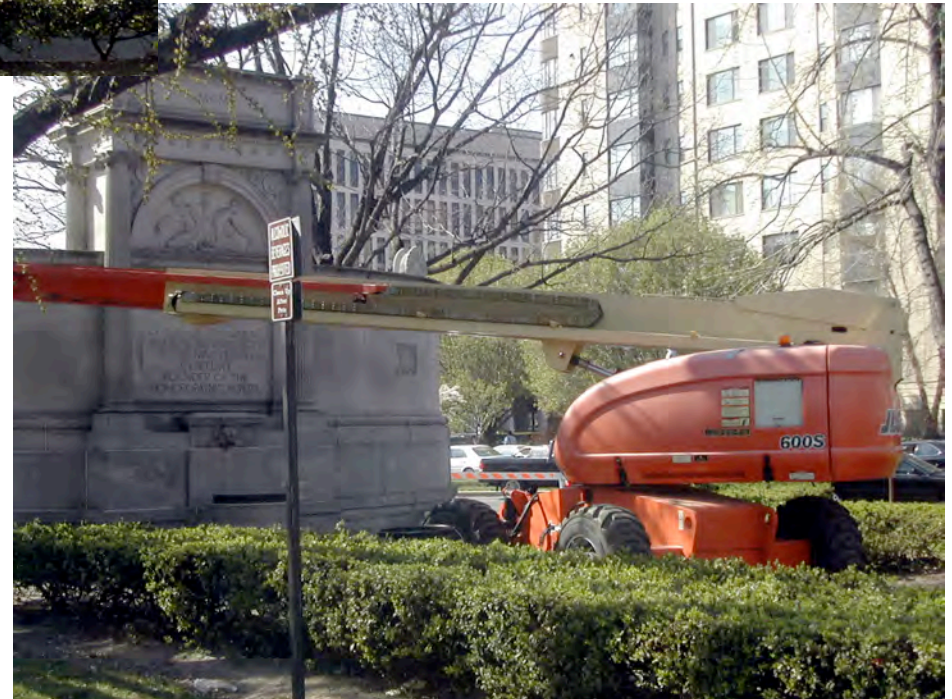
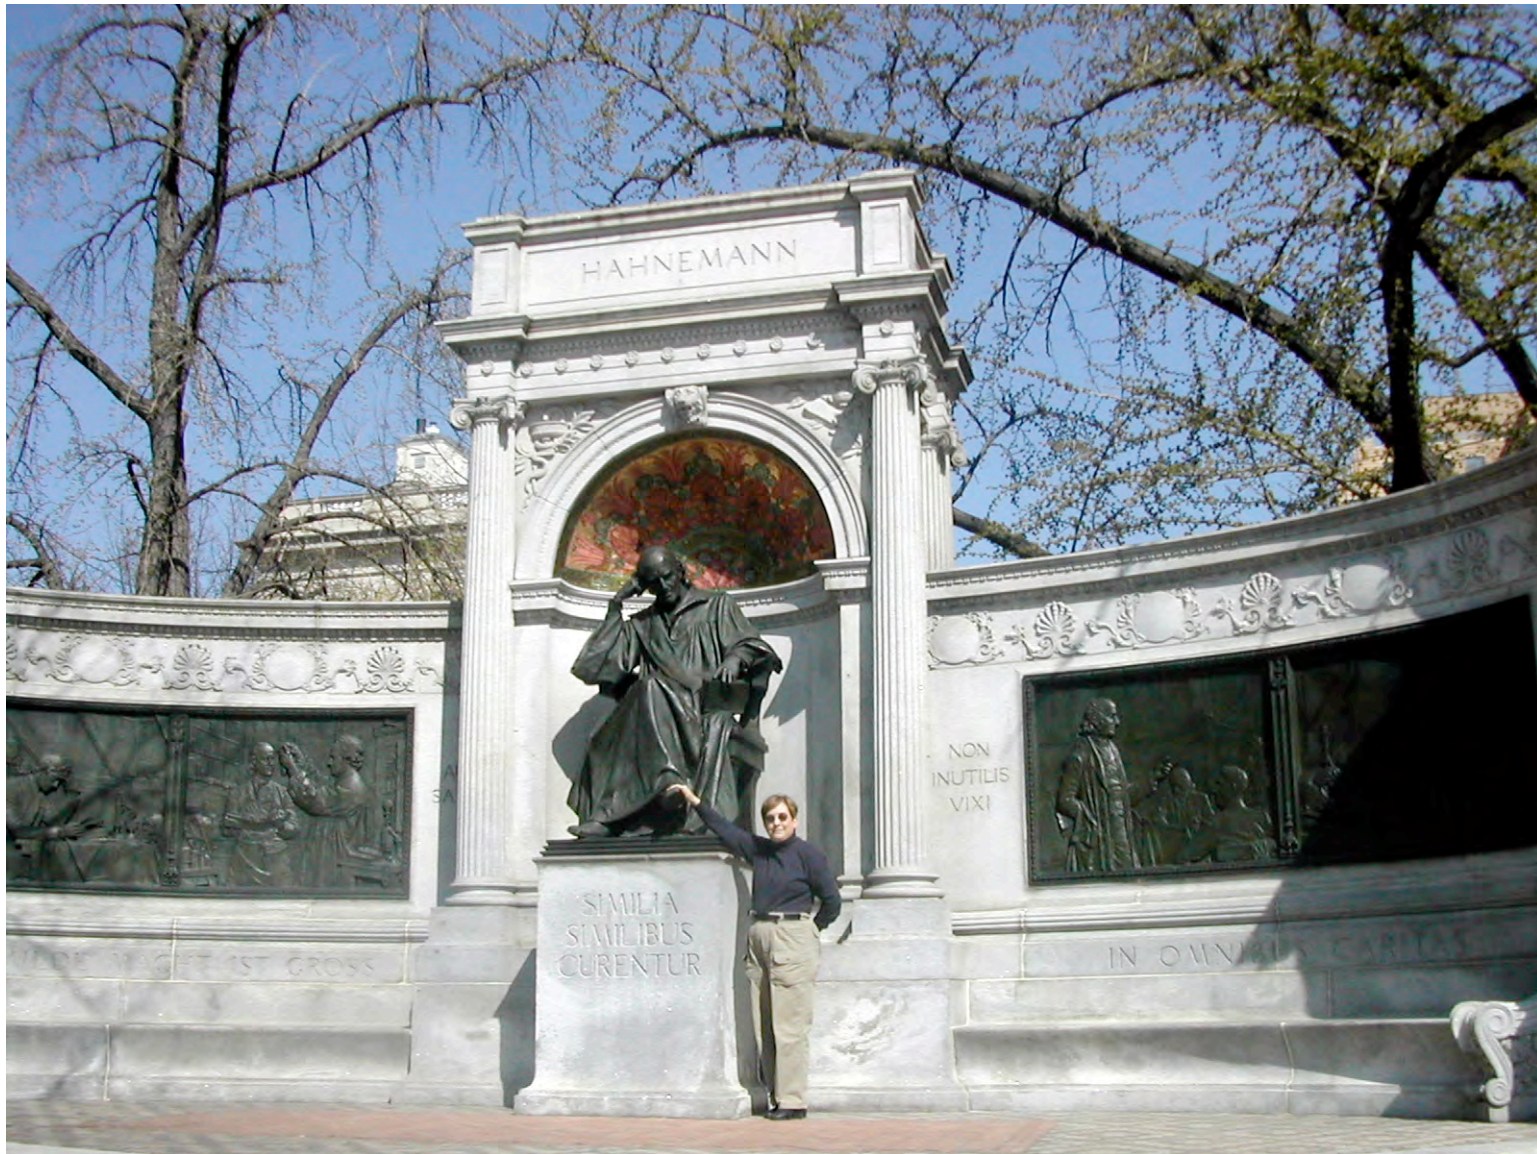
Attention is turning now to other phases of the HMRP, such as restoration of the plaza paving, which is settling to the right of the monument, as one faces it, and to the grounds of the park in which the monument rests to the east of Scott Circle.

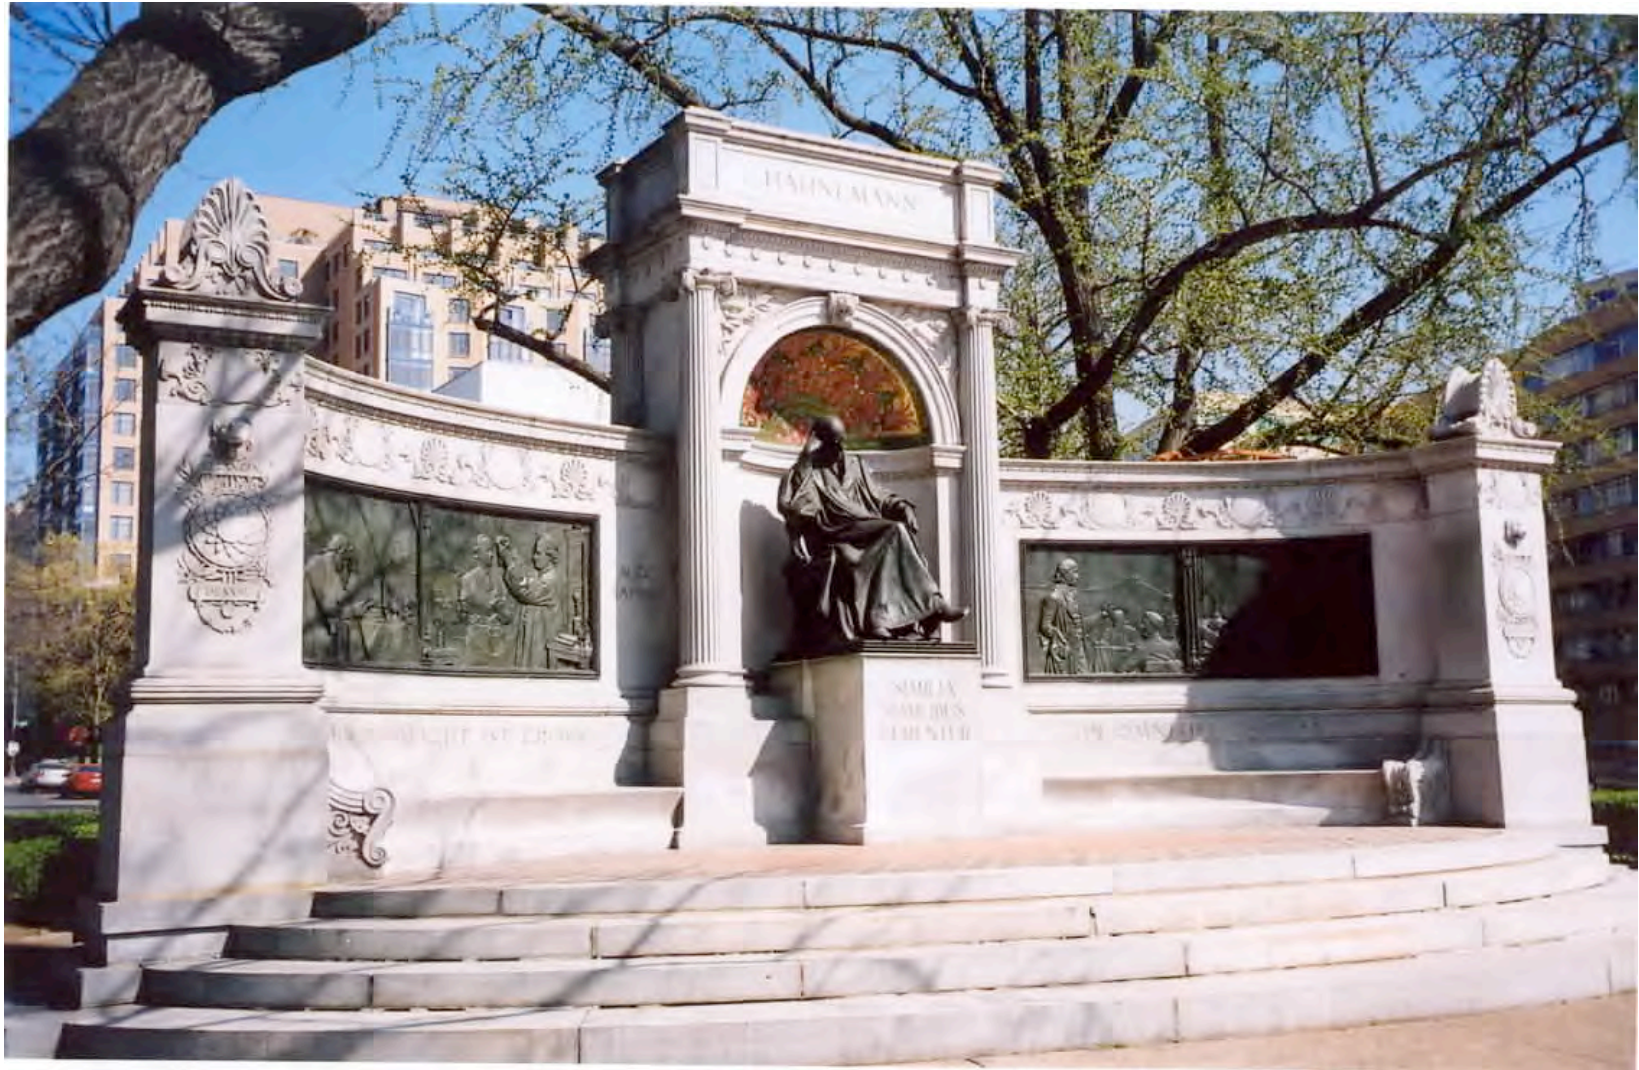
The lead joint T's had been installed at the top joints of the memorial. They provide a more permanent solution to the challenge of water intrusion and potential damage.

The mortar joints requiring repair were cut out last fall, but difficulties in acquiring the appropriate sand for the mortar delayed the completion of that part of the restoration until March of this year.
